**Peter M. Buenrostro**  
Residential and Commercial Property Inspections  
A Member of the Real Estate Inspection Group, Inc.  
[www.inspectiongroup.com](http://www.inspectiongroup.com)

**Inspection Address:** 339 Sonora Drive

**Inspection City:** San Mateo

**1-800-900-1239****www.inspectiongroup.com****PROPERTY INSPECTION****Inspection Address:** 339 Sonora Drive**Report Number:** 1110910PB**Inspection City:** San Mateo**Inspection Date:** November 9, 2010**Client's First Name:** Cecilia**Last:** Pang**Listing Inspection:** ☐ (Fee due within 90 days)**Agent's First Name:** Tim**Last:** Anderson**Phone:** (650) 279-7281**Ext:****Office:** Alain Pinel Realtors, Los Altos**Fax:****Inspector:** Peter M. Buenrostro**www.TheReportOnline.com Report password:** N/A**PRELIMINARY COMMENTS**

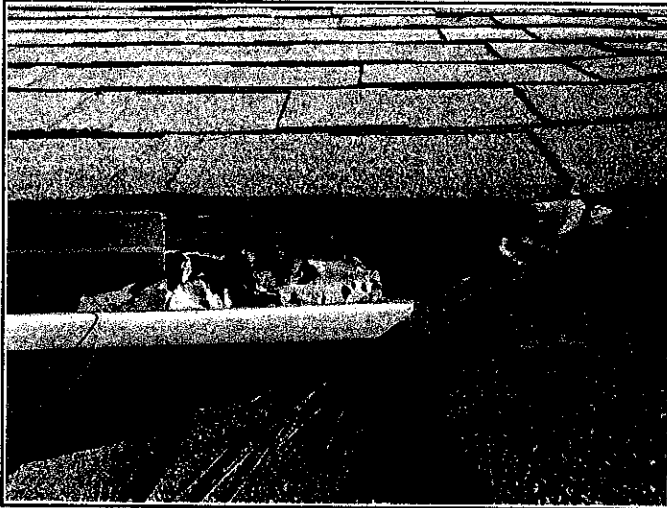
**PHOTO PAGE I****Photo 1**

The plywood sheathing at the right edge of the upper roof had some moss growth and surface damage. See "Exterior I Action Item 1(b)", page 5.

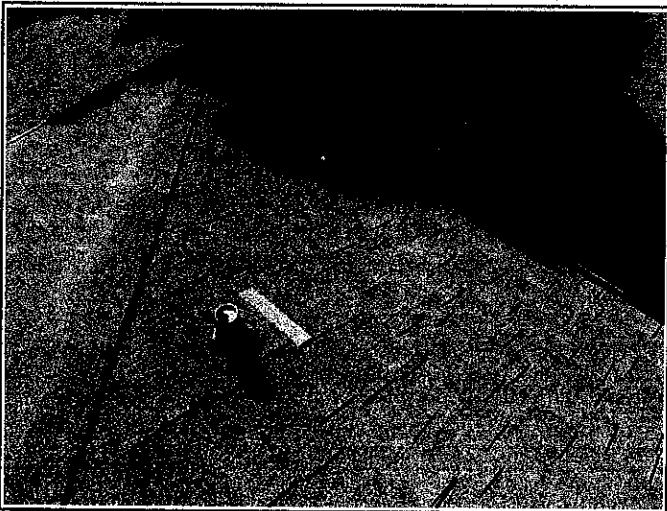
**Photo 3**

Plastic plugs in the tops of two vent pipes on the upper roof were broken, leaving the vent pipes open. See "Exterior I Action Item 1(e)" on page 23.

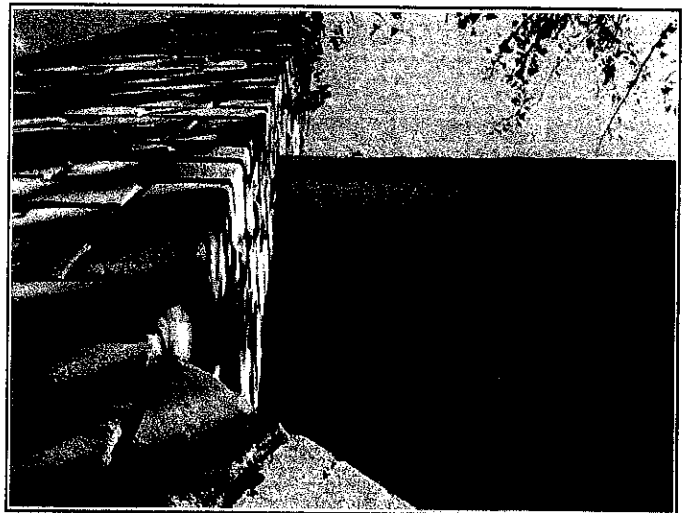
**Photo 4**

Eaves damage near the chimney. See "Exterior I Action Item 3(a)" on page 23.

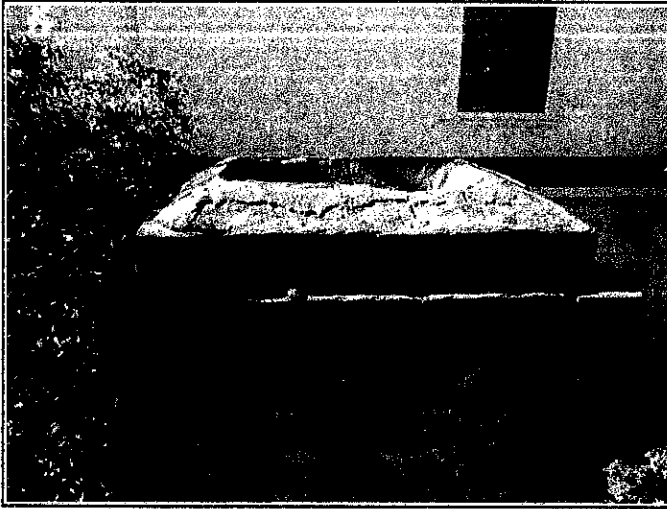
**Photo 5**

The top of the chimney had a loose brick and damage at the grout cap. The flue liner did not extend above the grout cap. A spark arrester/cap is needed. See "Exterior I Action Item 4", page 23.

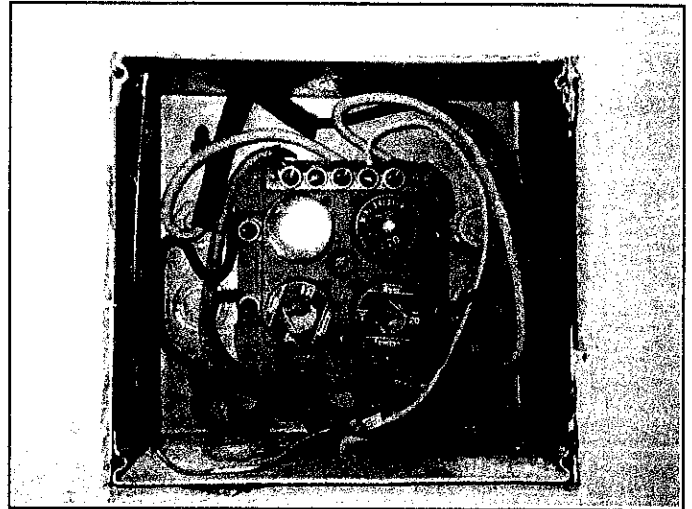
**Photo 6**

3) Fuse Box: The fuse box had a 20-amp mini-breaker as a fuse replacement and was labeled for the upstairs rooms. Ask the current owners if the mini-breaker was installed due to frequent blown fuses and if the mini-breaker trips often. The wire gauge appeared to be undersized for a 20-amp circuit (Photo 6) and should be evaluated by an appropriate licensed electrical contractor for possible corrections.

The wire gauge appeared to be undersized for the 20-amp "mini-breaker" circuit. See "Electrical Action Item 3" on page 7.

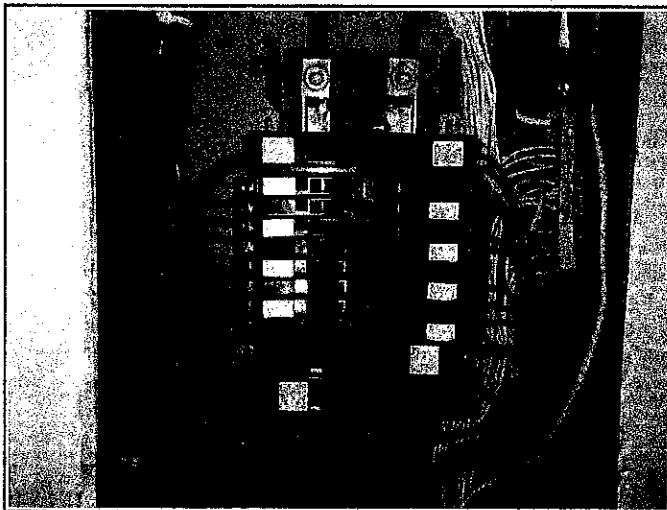
**Photo 7**

The two upper breakers in the sub panel each had two separate wires connected to their terminal. See "Electrical Action Item 4" on page 24.

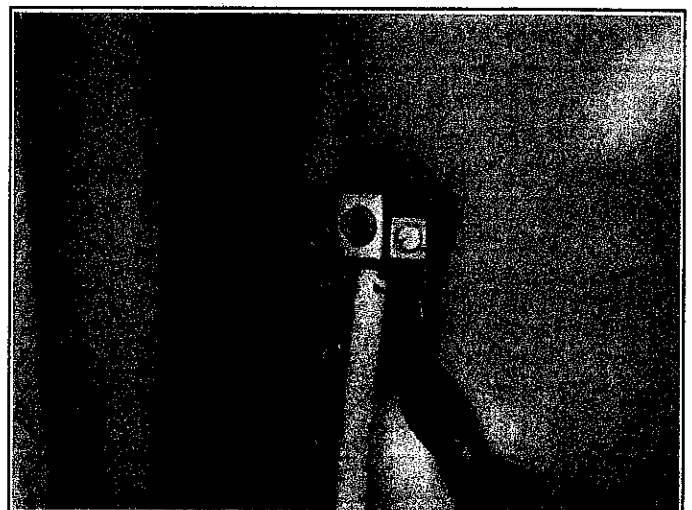
**Photo 8**

For Information: Two large ground connections visible inside the main panel. See "Electrical Action Item 5" on page 24 and Photo 9.

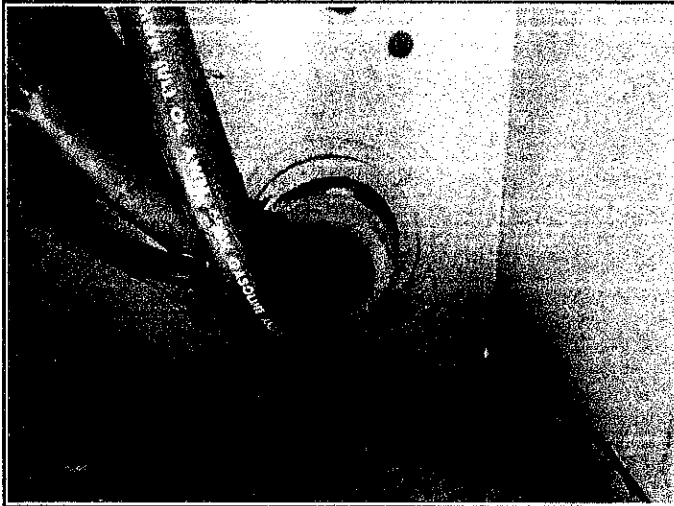
**Photo 9**

No visible grounding jumper connection at the concentric rings for the service feeder cables in the main panel. See "Electrical Action Item 5" on page 24.

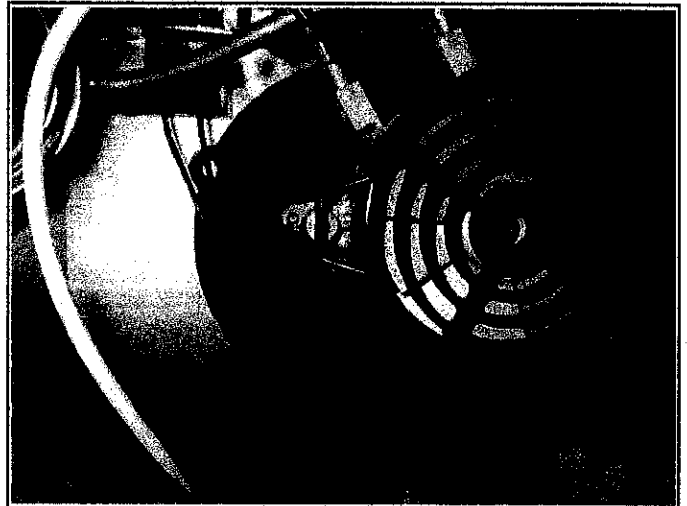
**Photo 10**

- 1) The furnace had a crack in the plastic draft inducer fan housing (Photo 10). I recommend further evaluation by an appropriate licensed HVAC contractor and repairs as needed. For reference, the furnace is a Rheem model RGDG-10NAMER, serial number BS35D302 F38927792.

The furnace had a crack in the plastic draft inducer fan housing. See "Heating System Action Item 1" on page 8.

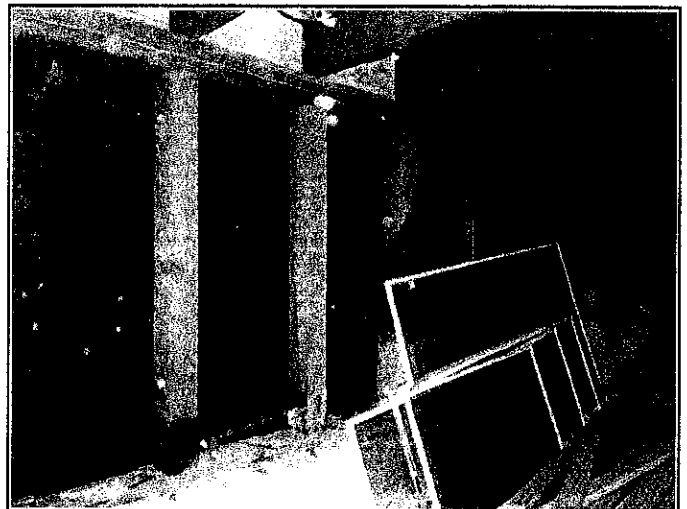
**Photo 12**

The left and right sides of the sub area crawlspace are presumed to have "unreinforced cripple walls". See "Foundation and Framing Action Item 1" on page 24.

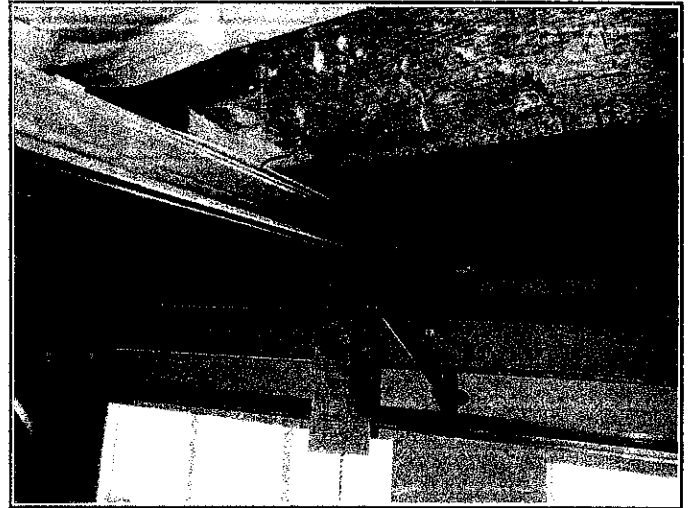
**Photo 14**

Some of the garage ceiling joists were notched to accommodate the garage door opener. See "Foundation and Framing Action Item 2" on page 24.

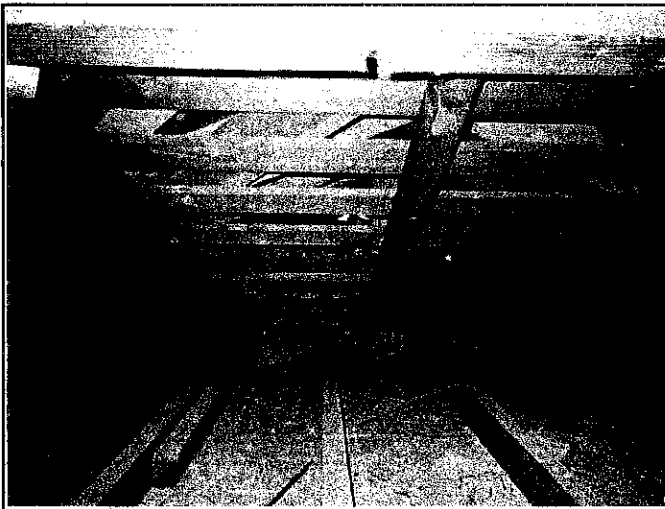
**Photo 15**

An inaccessible attic space behind the skip sheathing at the rear of the lower attic. See "Foundation and Framing Action Item 4" on page 245.

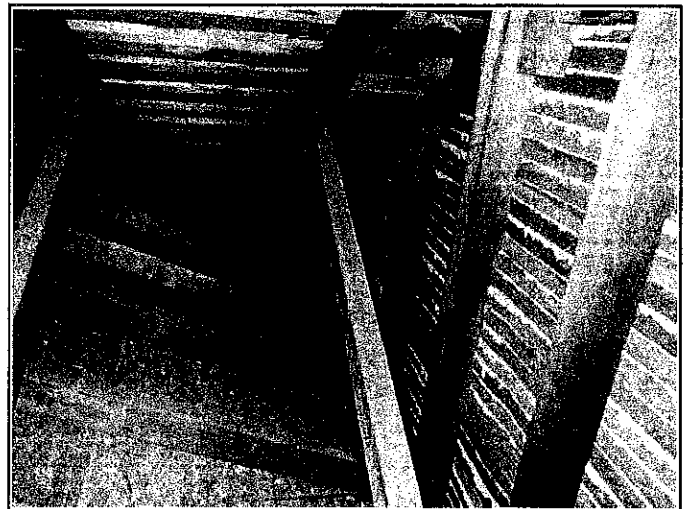
**Photo 16**

An uninsulated ceiling and conditioned wall in the lower attic. (Some other areas were insulated.) See "Foundation and Framing Action Item 5" on page 25.

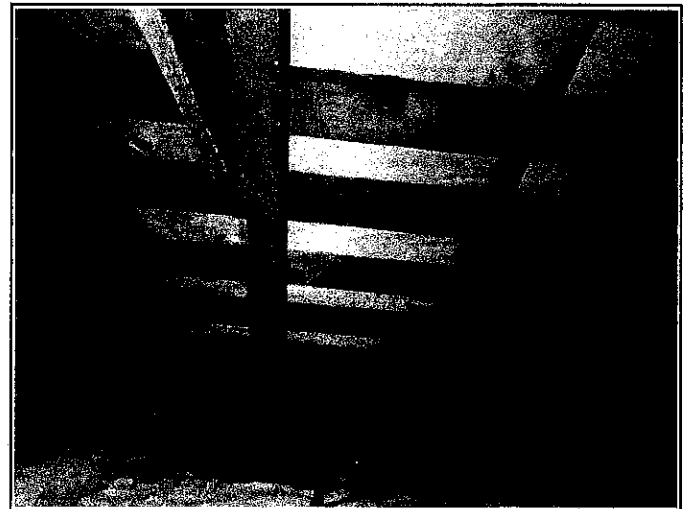
**Photo 20**

For Information Only: Some heat discolored skip sheathing in the upper attic. See "Foundation and Framing Action Item 9" on page 25.
